Subject: Site Assessment Report
Minton Enterprises, 5 West Monroe Street, Highland, Illinois
Technical Direction Document No. S05-0603-007
GSA Contract No. GS-10F-0076K

**SITE ASSESSMENT REPORT
MINTON ENTERPRISES SITE
HIGHLAND, MADISON COUNTY, ILLINOIS**

Date Prepared:	August 16, 2006
TDD No.:	S05-0603-007
Contract No.:	GS-10F-0076K
Prepared by:	Tetra Tech EM Inc.
Tetra Tech START Project Mgr.:	Thomas Binz
Telephone No.:	(314) 892-6322 ext. 25
U.S. EPA On-Scene Coordinator:	Kevin Turner
Telephone No.:	(618) 997-0115

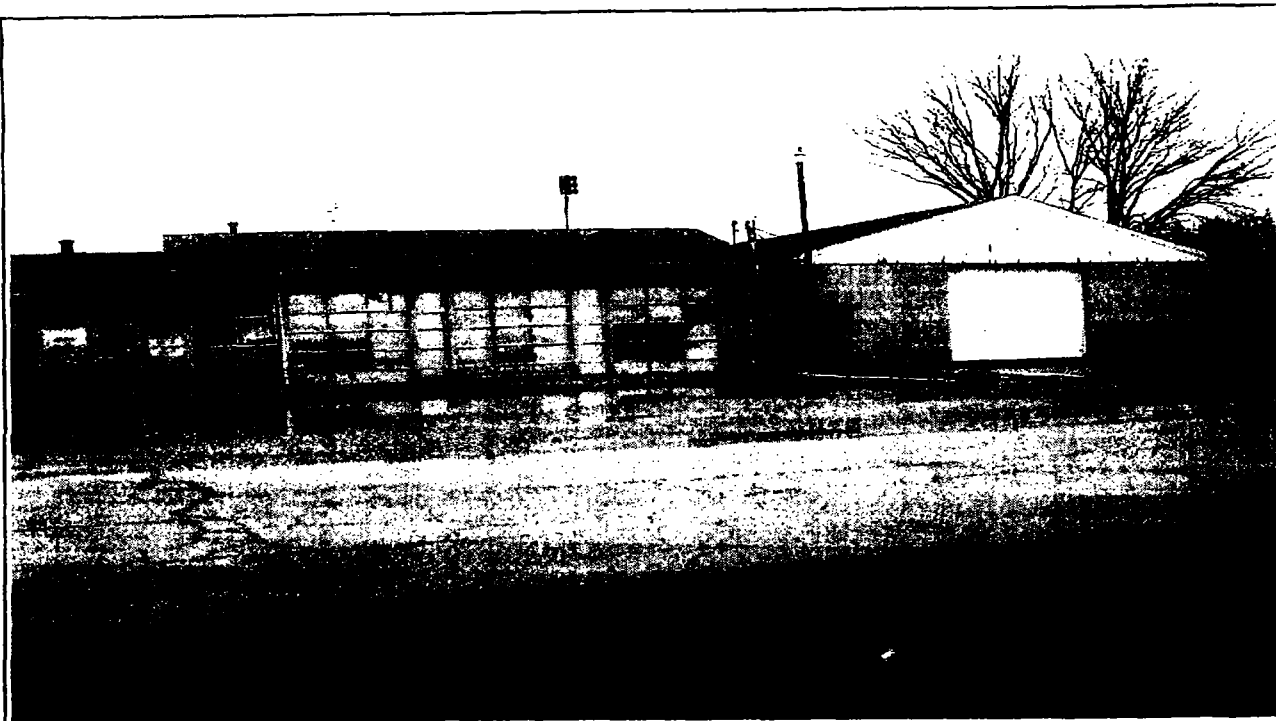
TETRA TECH PROJECT NO. G9009L0603007 Direction: North	DESCRIPTION	View of front of the Minton Enterprises facility. Monroe Street in foreground.	1
	CLIENT	U.S. Environmental Protection Agency Region 5	Date
	PHOTOGRAPHER	Tom Binz	4/6/2006

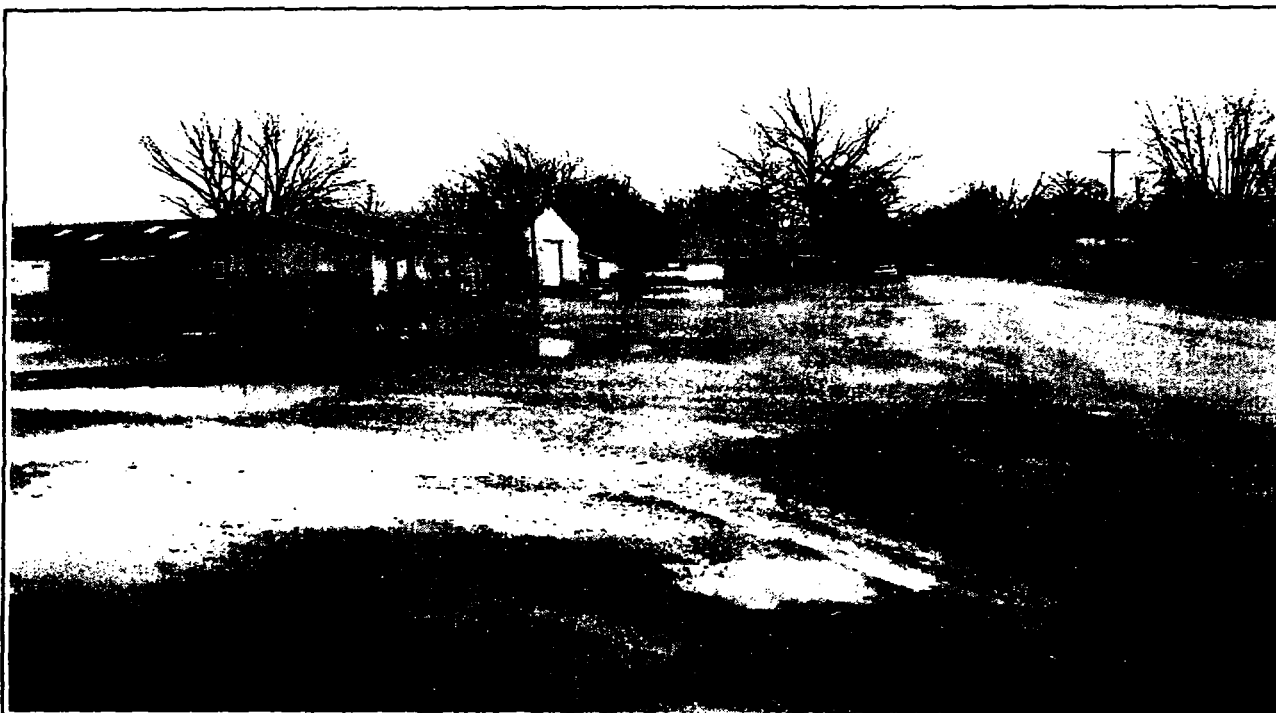
TETRA TECH PROJECT NO. G9009L0603007 Direction: East	DESCRIPTION	Standing on Monroe St. and looking towards the east direction.	5
	CLIENT	U. S. Environmental Protection Agency Region 5	Date 4/6/2006
	PHOTOGRAPHER	Tom Binz

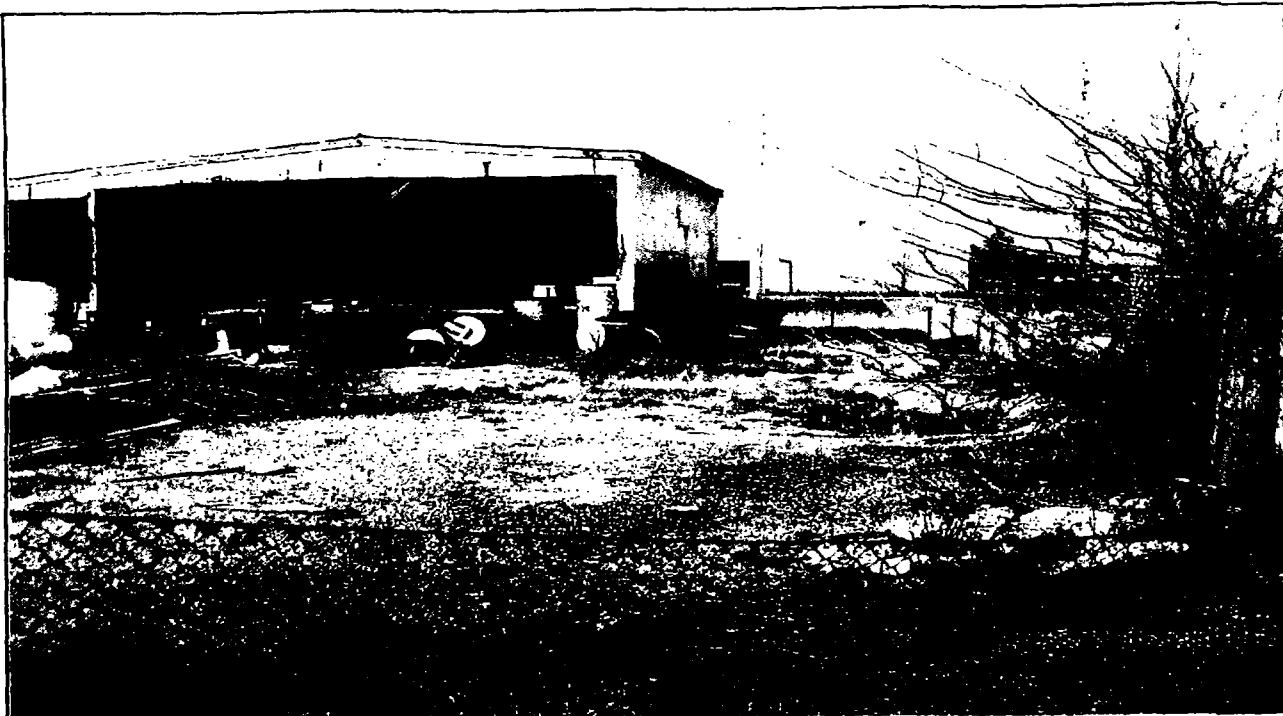
TETRA TECH PROJECT NO. G9009L0603007 Direction: West	DESCRIPTION	The outside storage area on the backside of the property. Drums and totes setting outside the building.	7
	CLIENT	U. S. Environmental Protection Agency Region 5	Date 4/6/2006
	PHOTOGRAPHER	Tom Binz

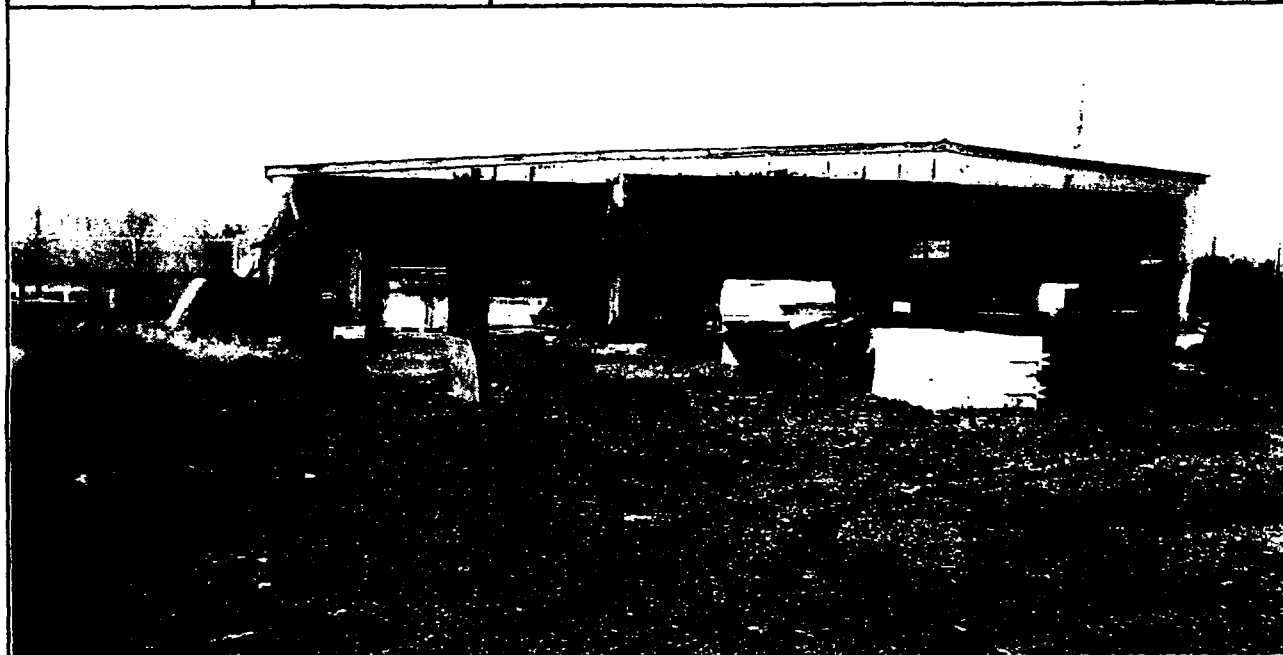
The outside storage warehouse is separated into three bays and is not insulated. The bays contain no doors and are open to the environment on the east side. It was estimated approximately 150 55-gallon drums are stored in the bays. Most of the drums appeared to be full. Some of the labels on the drums were examined and the labels indicated the drums contained phosphoric acid, chromic acid, nitric acid, and sodium hydrosulfite. The drums were loosely stacked two high, and if strong winds gust inside this outside storage warehouse, the wind may perhaps agitate or knock the drums down. In addition, drums exposed to the weather and subject to freezing and thawing conditions could further deteriorate the containers and cause a release.

TETRA TECH PROJECT NO. G9009L0603007 Direction: West	DESCRIPTION	The outside storage area on the backside of the property. Open and unsecured bays containing drums of hazardous materials.	8
	CLIENT	U. S. Environmental Protection Agency Region 5	Date 4/6/2006
	PHOTOGRAPHER	Tom Binz

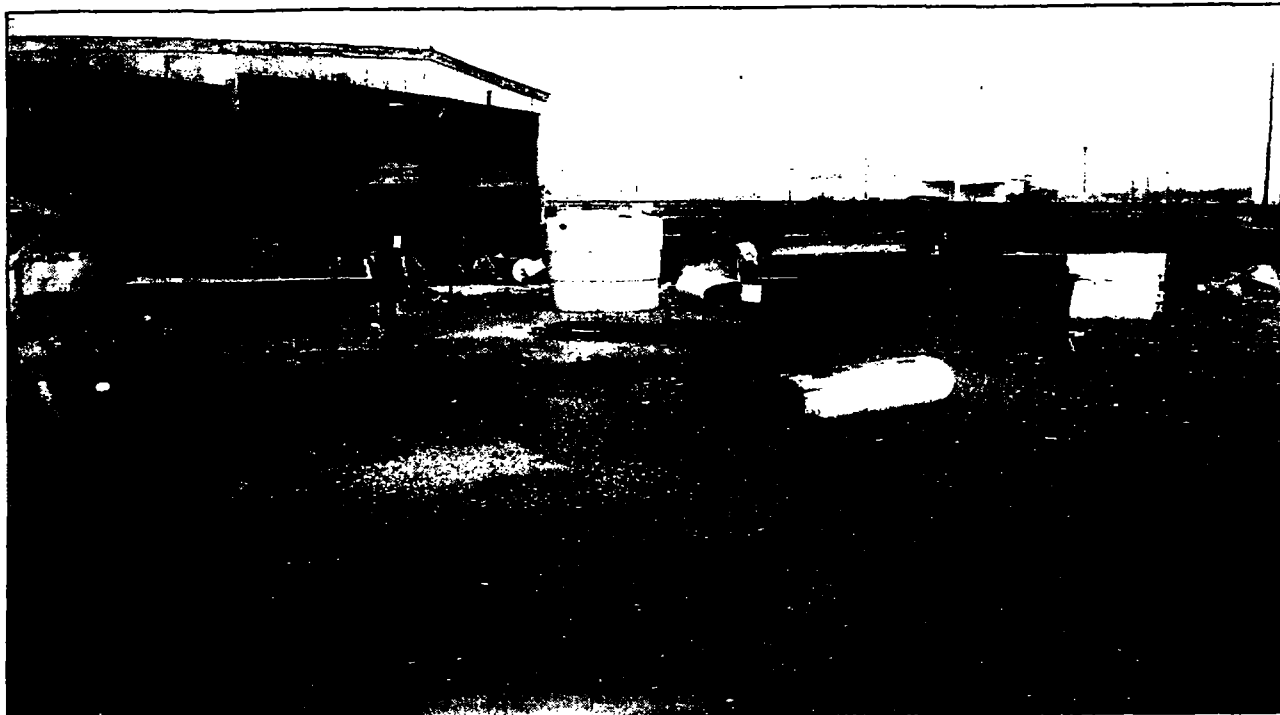
TETRA TECH PROJECT NO. G9009L0603007 Direction: North	DESCRIPTION	Look at the front of the outside storage area. Totes, drums and plating equipment scattered around the area.	9
	CLIENT	U. S. Environmental Protection Agency Region 5	Date
	PHOTOGRAPHER	Tom Binz	4/6/2006

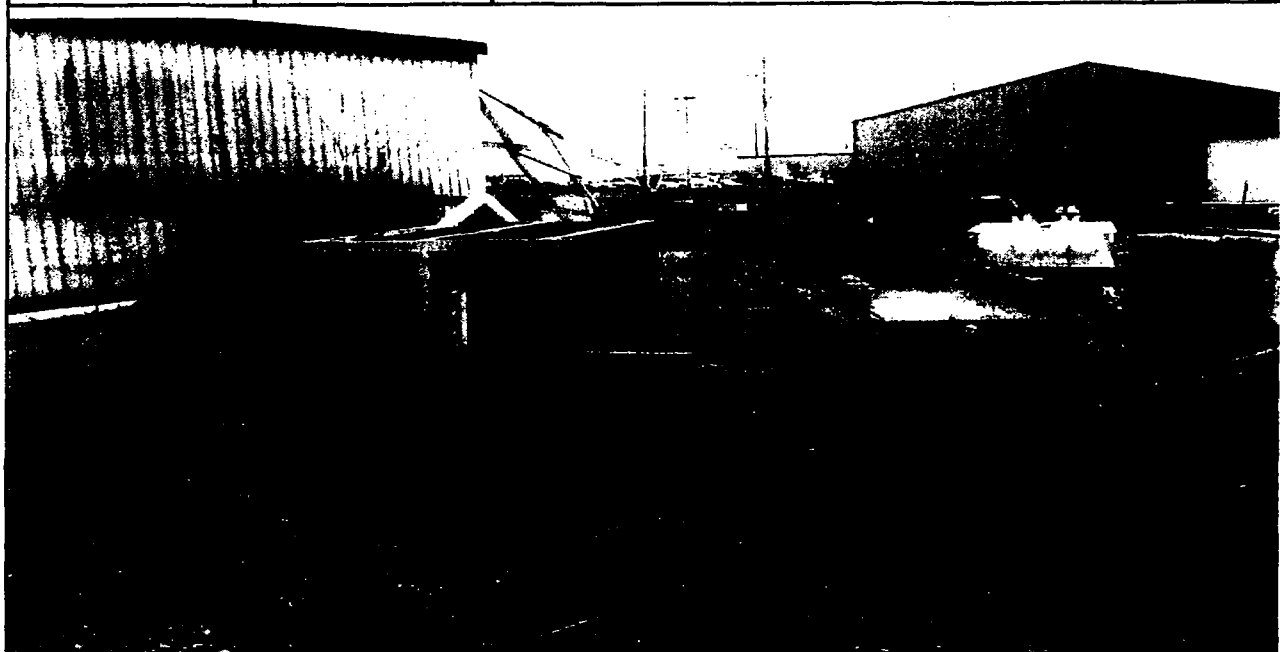
TETRA TECH PROJECT NO. G9009L0603007 Direction: Northeast	DESCRIPTION	Look at the front of the outside storage area. Totes, drums and equipment scattered around. Main building in background.	10
	CLIENT	U. S. Environmental Protection Agency Region 5	Date
	PHOTOGRAPHER	Tom Binz	4/6/2006

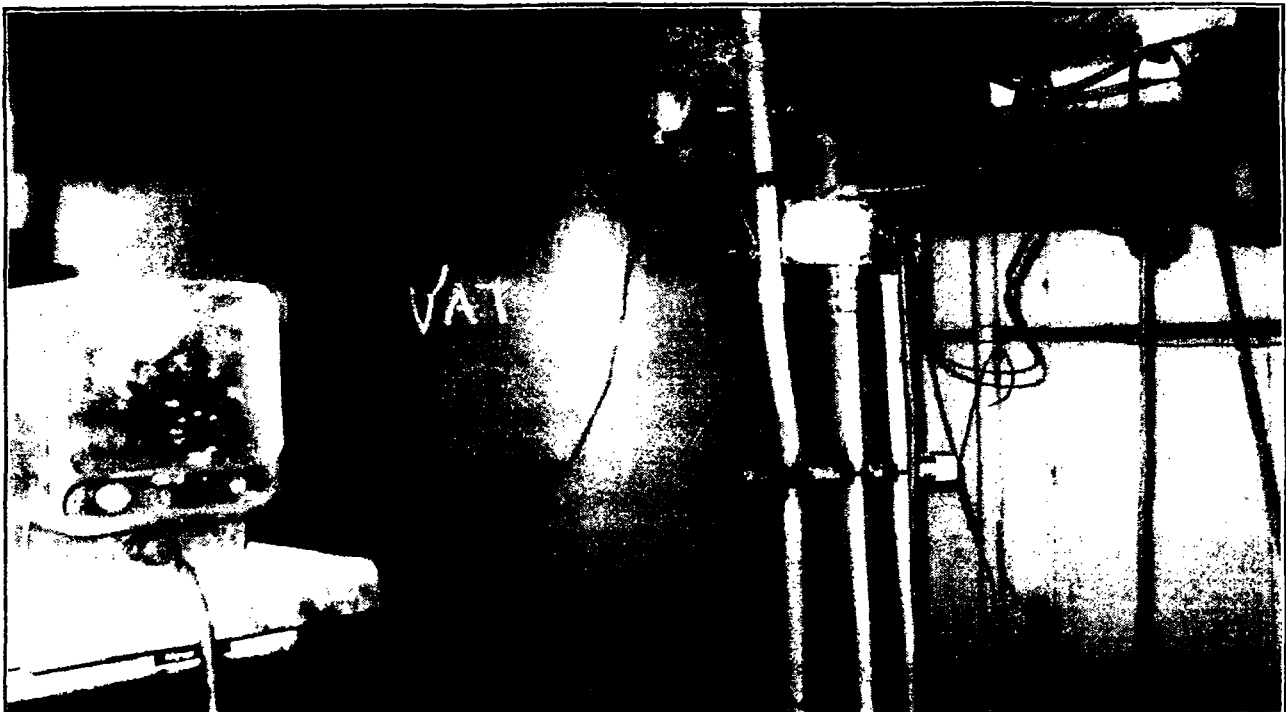
TETRA TECH PROJECT NO. G9009L0603007 Direction: North	DESCRIPTION	Vat #2 Located in the waste treatment area. Located in the front central portion of the building.	13
	CLIENT	U. S. Environmental Protection Agency Region 5	Date
	PHOTOGRAPHER	Michael Grant – IEPA	4/6/2006

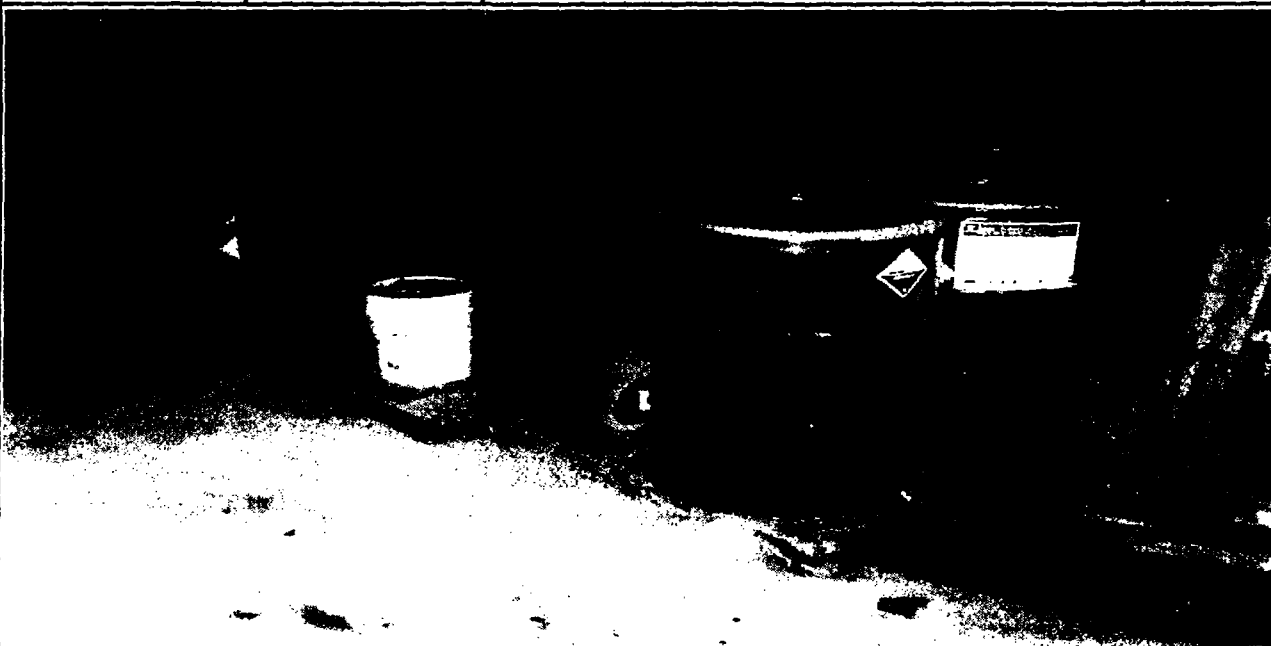
TETRA TECH PROJECT NO. G9009L0603007 Direction: Northeast	DESCRIPTION	Drums setting in the storage area labeled corrosive.	16
	CLIENT	U. S. Environmental Protection Agency Region 5	Date 4/6/2006
	PHOTOGRAPHER	Michael Grant- IEPA

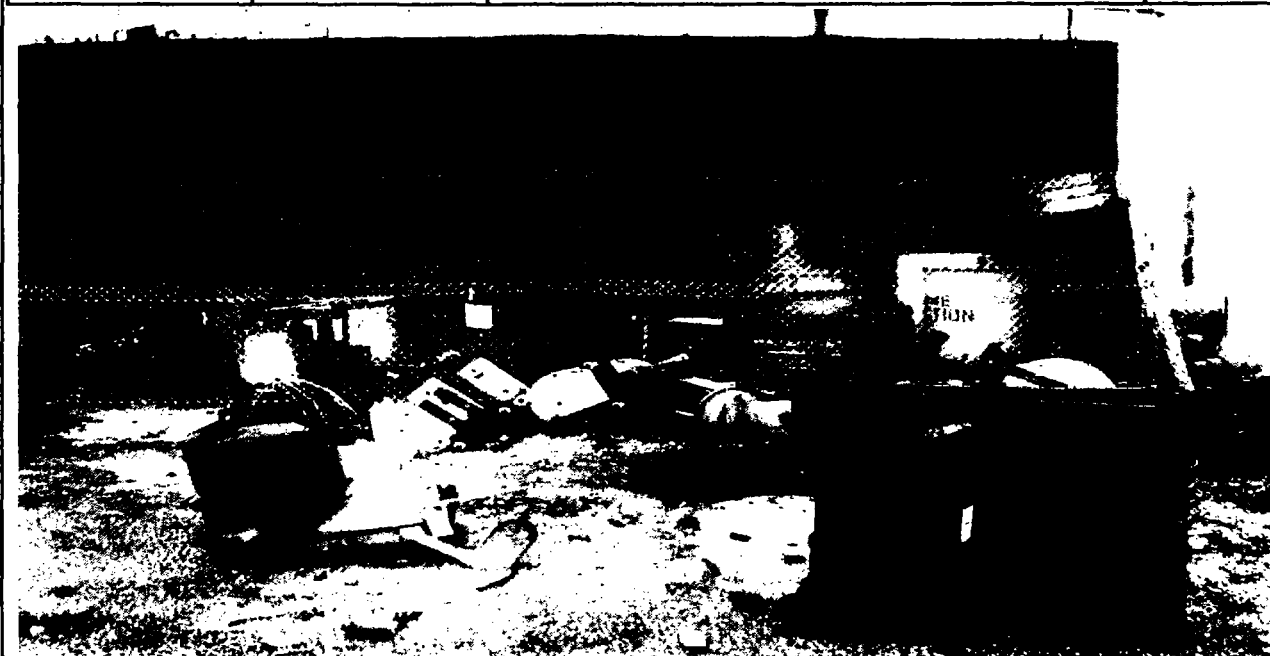
TETRA TECH PROJECT NO. G9009L0603007 Direction: West	DESCRIPTION	Outside storage area with equipment a drums outside not sheltered but secured with cyclone fence.	28
	CLIENT	U. S. Environmental Protection Agency Region 5	Date
	PHOTOGRAPHER	Michael Grant - IEPA	4/6/2006
